New Hampshire
DOT
Research Record

Use of Ground Penetrating
Radar to Delineate Bridge Deck
Repair Areas

Final Report

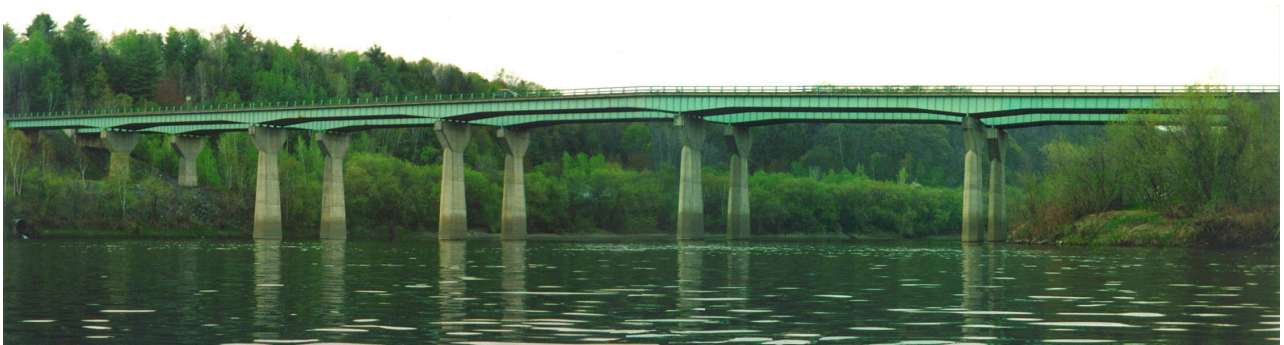
Figure 2. Elevation view of twin bridges carrying I89 over the Connecticut River between New Hampshire and Vermont.

The 842-foot (257 m), two-structure, four-lane bridge deck system spanning the Connecticut River on I-89 was evaluated by GSSI during the spring of 1998, and a rehabilitation strategy based largely on the GPR results was developed by NHDOT to repair the asphalt-overlaid bridge deck. The project goals were to simultaneously: (a) extend the service life of the structures an additional ten years or more; (b) maintain the bridge deck structures using a sequence of cut-and-patch operations, allowing unimpeded traffic flow on the structure during daytime hours; and (c) investigate the effectiveness of a new GPR technology's ability to accurately determine concrete deterioration levels and their boundaries on a plan view map of the structure.

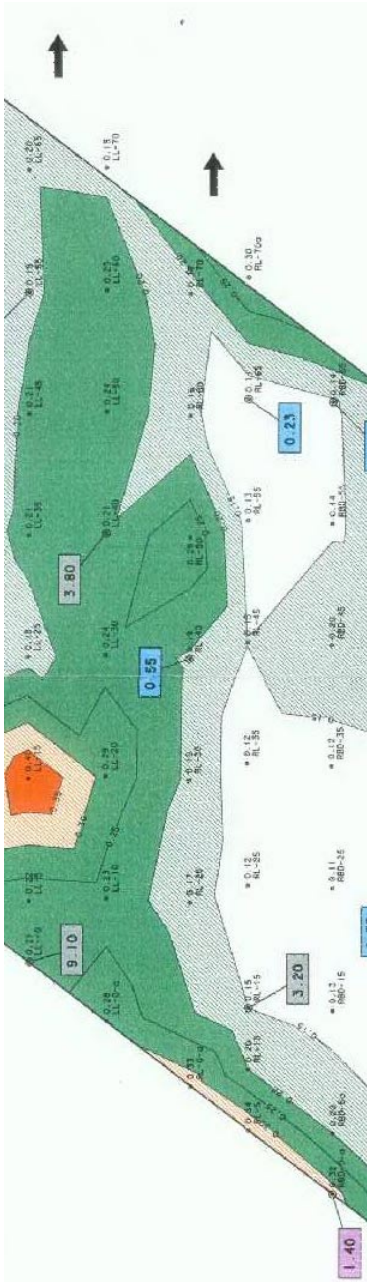
I93 SB over Mirror Lake Road

GPR

Half-Cell Potential (Red
Shading = Active)

Chloride Content (Gray
Box = Active)

consistent with the GPR data. Appendix A shows the comparative, visual results from each of the four bridge decks using GPR data from GSSI.
